INSPECTION REPORT

1234 Sample Street
Tucson, AZ 85701

1/30/2008

FILE CODE: 0100114.SAM

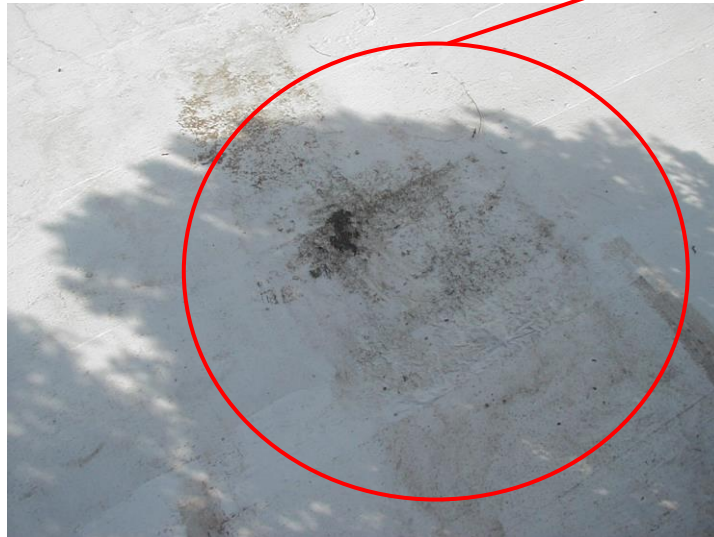
R.2B Coatings: Surface coating is needed. An application of reflective coating is needed every two to four years as normal maintenance for this type of roof. Elastomeric coating is recommended.

RC.1 Surface Coating Needed

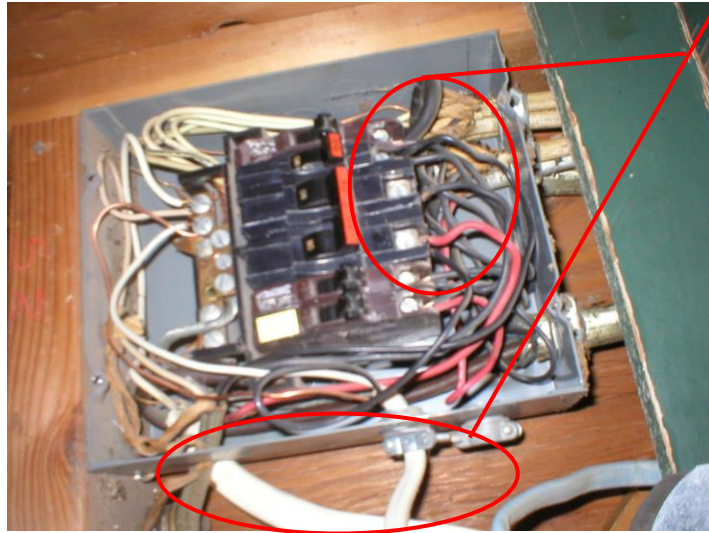
Electric: Double-tapped breakers are present at the sub-panel; recommend installation of additional breakers and further evaluation/repair by a licensed electrician. (Safety Hazard) Also, surface mounted exposed Romex wiring requires encapsulation (conduit) at the sub-panel.

U.1 Double-Tapped Breakers & Surface Mounted Romex Wiring
